**APDES INSPECTION REPORT**  
 Alaska Department of Environmental Conservation  
 Division of Water  
 555 Cordova St., Anchorage, AK 99501

Inspection Date	Permit #	Borough	Receiving Waters	Weather	Facility Type
12/16/2008	AKR05A703	Kenai Peninsula	Resurrection Bay	Current Conditions: Clear skies, ~20°F, light winds Days since last precipitation >0.1 inches: 7 (12/09/2008)	Industrial

<b>Name and Location of Site/ Facility Inspected</b>		<b>Entry Time</b>	<b>Permit Effective Date</b>												
Aurora Energy Services, LLC 903 Port Avenue Seward, AK 99644		14:00	09/25/2004												
<b>Loc:</b> Lat: Long: Source: not recorded		<b>Exit Time</b>	<b>Permit Expiration Date</b>												
		15:00	Administratively extended												
<b>On-Site Representative</b> Vic Stoltz, General Foreman		<b>Additional Participants:</b> Brent Andrews, ADEC Kara Kusche, ADEC													
<b>Responsible Official(s):</b>															
Vic Stoltz AES P.O. Box 1789 Seward, AK 99644 <input checked="" type="checkbox"/>	(intentionally left blank)  <input type="checkbox"/> Contacted?

**PHOTO ADDENDUM – AURORA ENERGY SERVICES 12/16/2008**

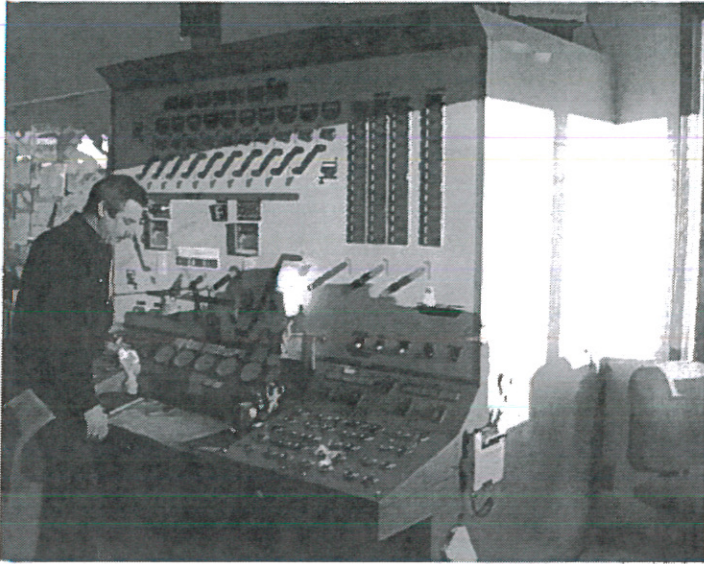
The facility has added additional spray bars and is in the process of expanding even more on the number of spray bars to dampen the coal and thus prevent dust. Aurora Energy Services has a standard operating procedure that states they will have a person monitoring for dust and are to turn on the sprayers if dust is detected. This is utilized in all 4 seasons. If excessive dust cannot be controlled despite control measures, the operation is to shut down until weather and/or control measures allow for dust-free operations. Vic stated that the facility employs one staff member to monitor the transfer of coal for dust. Vic also explained the facilities system of dealing with stormwater, including settling ponds (frozen on day of visit), culverts, outflow to Resurrection Bay, and directions of stormwater. We reminded Vic that the facility will need to submit and updated Stormwater Pollution Prevention Plan (SWPPP) in accordance with the new 2008 Multi-Sector General Permit for

PHOTO 1: FOREMAN EXPLAINING SPRAY BAR SYSTEM AND LOG OF KEPT RECORDS. LOCATION IS CONTROL AND MONITORING TOWER.

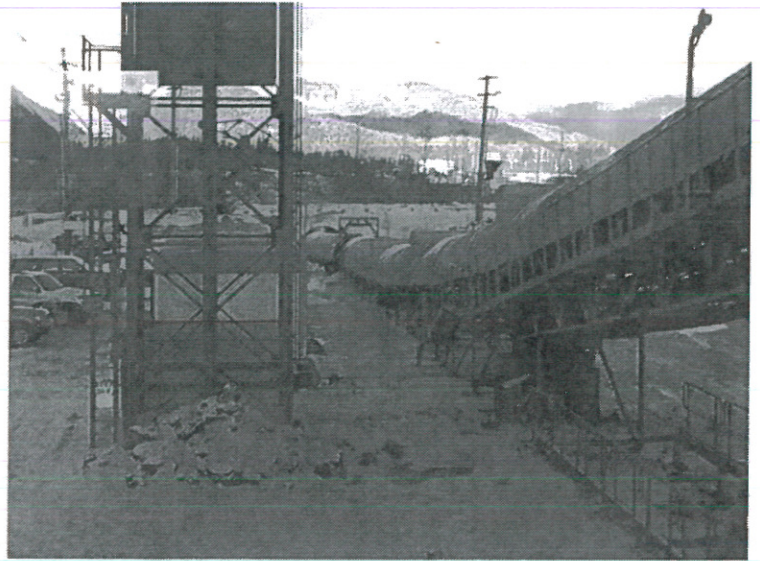
On December 16, 2008 13:50 ADEC Inspectors Kara Kusche and Brent Andrews drove the road outside the facility looking for evidence of fugitive coal dust which had left the facility property. We did not see evidence of this, surrounding snow was white in color and air was clear (see photos 2, 3, 4, and 5). At 14:00 we entered Aurora Energy Services and met with Vic Stoltz. We informed him that we were there to follow up on a concerned citizen complaint and showed Vic the photos dated January 29<sup>th</sup> and February 1<sup>st</sup> and 8<sup>th</sup> of 2008 (last winter). ADEC also received photos dated December 15<sup>th</sup>, 2008 (the day before our complaint investigation) but these conditions did not match what ADEC found during their site visit. Vic Stoltz was cooperative in answering ADEC's questions regarding their operations and best management practices regarding coal dust (see photo 1). He did acknowledge some dusty conditions during the time period of the photos last year and also discussed improvements that the facility has since made in response.

PHOTO 2: VIEW FROM MONITORING TOWER LOOKING OVER YARD AND COVERED CONVEYER BELT.

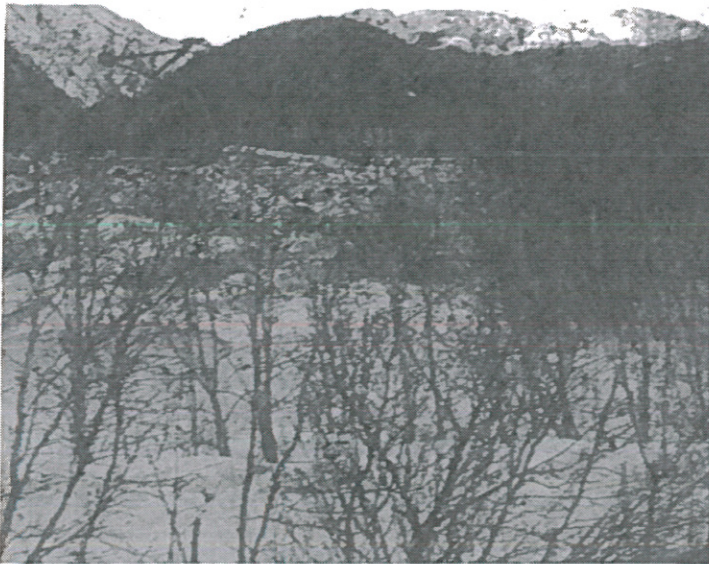
PHOTO 3: SNOW AND VEGETATION LOCATED ACROSS ROAD FROM FACILITY.

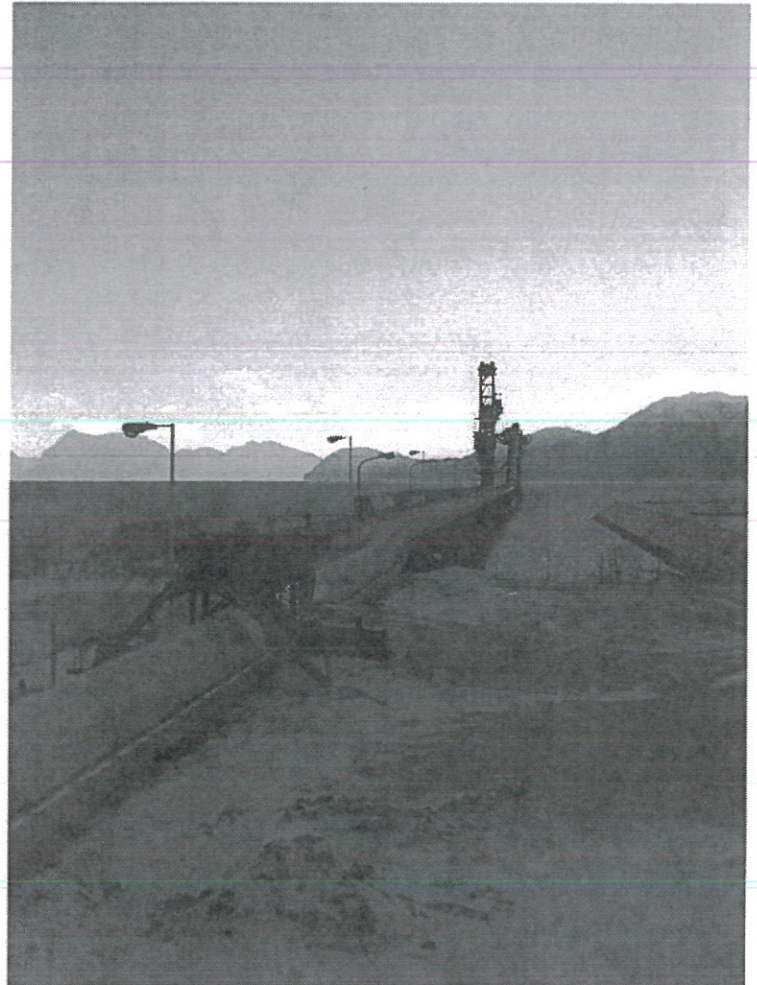
PHOTO 4: COVERED CONVEYER BELT LEADING TO TRANSFER LOCATION AT RESURRECTION BAY.

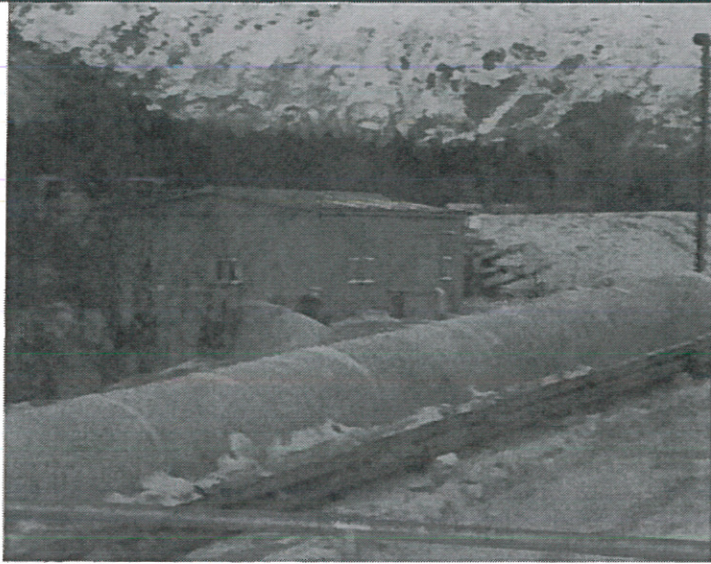
PHOTO 5: ANOTHER VIEW OF CONVEYER BELT AND AREA SNOW.
